**Flood Control Project Maintenance
Levee Inspections**
LMA District Cover Sheet
Spring 2017 Levee Inspection Results

Sutter Maintenance Yard Maintenance Area 0007

Levee Inspection Report By Mile - Spring 2017

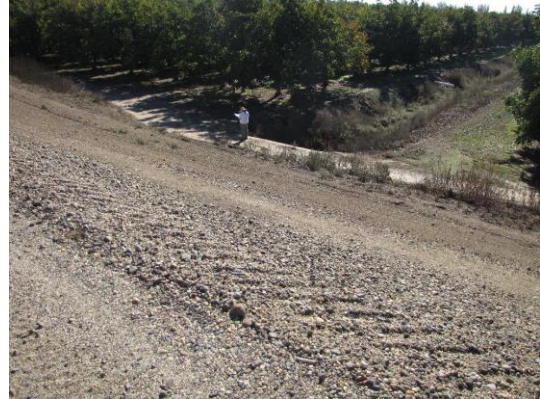
Photo 1 of 3 : UCIP_SP_2017_48006_65911.jpg

FS_ID:48006
DS_ID:17013
EP_NO: N/A
Repair Type: Non-Urgent
Crossing Status: Found
UCIP Comments: 5/16/2016 Feather River West Levee Improvement Project--Levee currently under construction. Crossing, referenced as STA 1961+10, will be removed as indicated in the project Plans for Construction of Feather River West Levee Project, Project Area A, Feather River West Levee Improvement Plans, Sta 1765+00 to 2368+26, Volume 3 of 5. The 2-60 inch pipes will be replaced with a single 36-inch pipe.6/10/2015 Sediment still blocking the flap gates on WS. LS inlet being overgrown by vegetation in the ditch.12/29/2014 Same as last inspection.5/19/2014 Same as last inspection.11/7/2013 Same as last inspection.5/13/2013 SBFCA project recommends relacing in accordance with title 23.5/10/2013 Same as last inspection.11/5/2012 Sediment blocking flap gate--need to remove sediment to make flap gates operational.
FIELD_STRUCT_DESC: 2 of 2: 60-inch corrugated metal drainage pipe (upstream pipe) through the levee, 23.4 feet below the crown. Concrete headwalls on both the waterside (WS) and landside (LS) ends. Flap gate on the WS end. Ditch located at WS outlet. (USACE O&M Manual, 1957) [Additional Reference(s): DWR Levee Log, 2005. USACE Sacramento O&M Manual 152, March 1957 (Station 195+80)]

View of WS with clear slope.

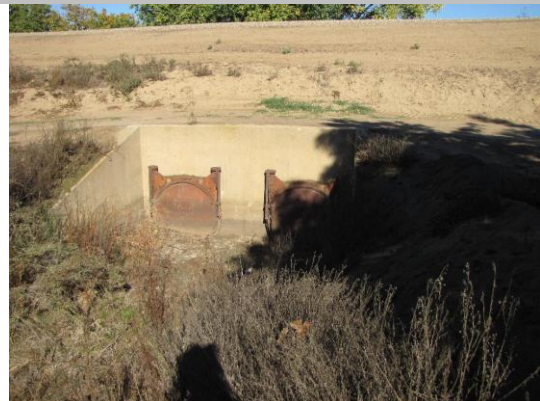
Photo 2 of 3 : UCIP_SP_2017_48006_65910.jpg

View of headwall and flap gates located on WS.

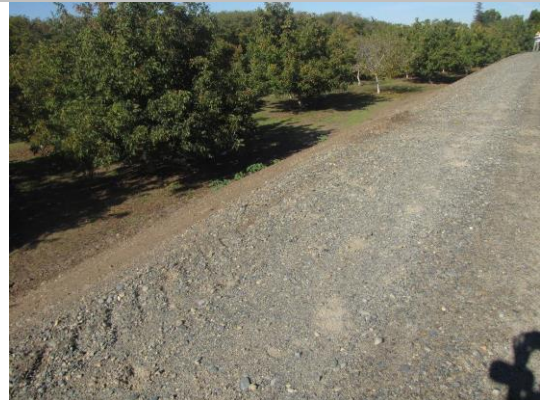
Photo 1 of 3 : UCIP_SP_2017_48007_65923.jpg

Comment Code					
Inspector Comment					
FS_ID:48007 DS_ID:16960 EP_NO: 17895 Repair Type: Non-Urgent Crossing Status: Indicator Found UCIP Comments: 5/16/2016 Feather River West Levee Improvement Project--Levee currently under construction. Crossing, referenced as STA 2084+03, will be removed and replaced as indicated in the project Plans for Construction of Feather River West Levee Project, Project Area A, Feather River West Levee Improvement Plans, Sta 1765+00 to 2368+26, Volume 3 of 5.6/10/2015 Minor erodin still present near air vent.12/30/2014 Same as last inspection.5/19/2014 Same as last inspection.11/7/2013 Same as last inspection.11/5/2012 localized erosion at air vent located on WS shoulder; this crossing appears to have leaking at the air vent--will need to determine reason for erosion at air vent (vehicles going over vent?); also recommend installing utility marker. FIELD_STRUCT_DESC: 5-inch steel irrigation pipe through the right (west) bank levee at an unknown depth below the crown. Pipe connects to existing pipe within the overflow area of the Feather River. (Permit No. 17895, 2005 - John Kucek) FS Date: 5/16/2016 10:30:00 AM

View of LS and levee crown looking upstream towards crossing.

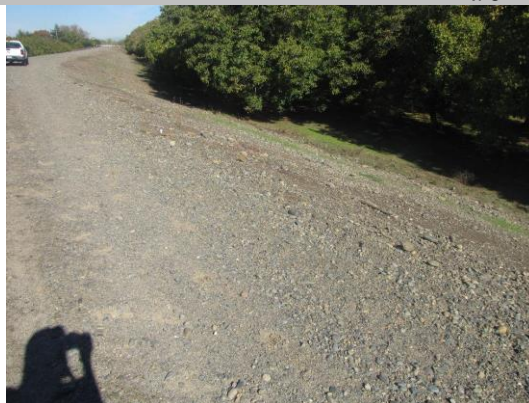
Photo 2 of 3 : UCIP_SP_2017_48007_65922.jpg

View of WS and levee crown looking upstream towards crossing.

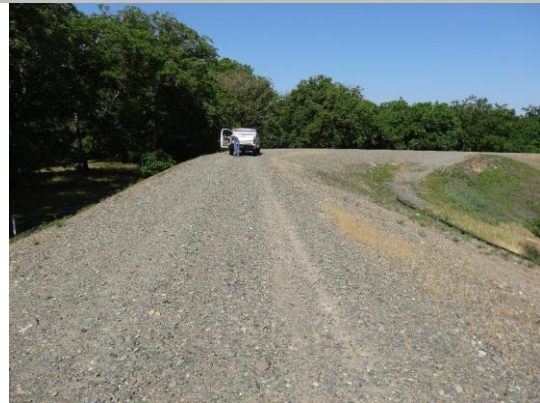
Photo 1 of 3 : UCIP_SP_2017_49919_65926.jpg

Comment Code					
Inspector Comment					
FS_ID:49919 DS_ID:23096 EP_NO: N/A Repair Type: Urgent Crossing Status: Indicator Found UCIP Comments: 5/16/2016 Feather River West Levee Improvement Project--Levee currently under construction. (DWR Sutter Yard - afreitag)6/10/2015 Same as last inspection. (DWR Sutter Yard - afreitag)12/30/2014 Same as last inspection. (DWR Sutter Yard - afreitag)5/19/2014 Same as last inspection. (DWR Sutter Yard - afreitag)11/7/2013 Same as last inspection. (DWR Sutter Yard - afreitag)5/9/2013 Depression along WS slope that could indicate a leak or poor compaction. Unknown permit number need to coordinate with landowner to find out more info. (DWR UCIP - omagana) FIELD_STRUCT_DESC: Irrigation pipe of unknown material through the levee at an unknown depth below the crown. Steel standpipe located on the landside (LS) toe. Also present is 4.5-inch polyvinyl chloride (PVC) pipe near standpipe located on the LS toe. No permit has been identified since crossing was field discovered in 2012. FS Date: 5/16/2016 10:31:00 AM

Overview from crown looking U/S

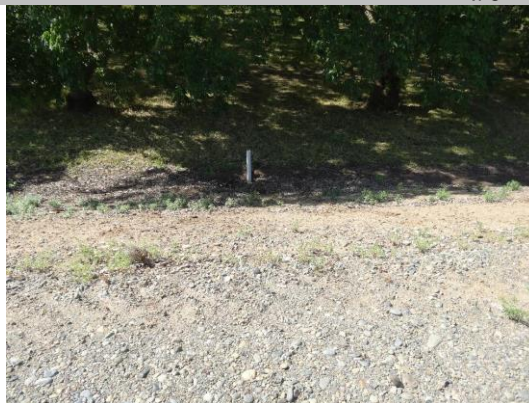
Photo 2 of 3 : UCIP_SP_2017_49919_65925.jpg

LS slope

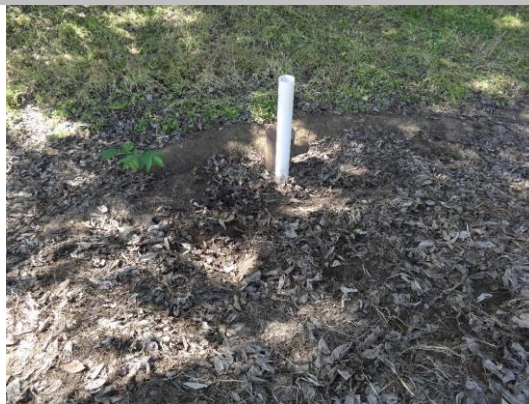
Photo 3 of 3 : UCIP_SP_2017_49919_65924.jpg

PVC and steel pipe on LS toe

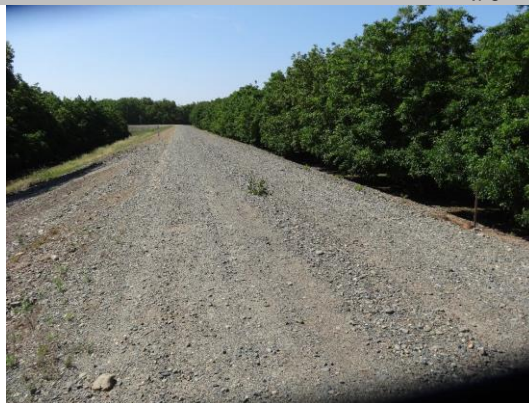
Photo 1 of 3 : UCIP_SP_2017_47873_65930.jpg

Comment Code					
Inspector Comment					
FS_ID:47873 DS_ID:23094 EP_NO: N/A Repair Type: Non-Urgent Crossing Status: Indicator Found UCIP Comments: 5/16/2016 Feather River West Levee Improvement Project--Levee currently under construction.6/10/2015 same as last inspection.12/30/2014 Same as last inspection.5/19/2014 Same as last inspection.11/7/2013 Same as last inspection.5/9/2013 Unknown permit coordinate with landowner to find out more information. FIELD_STRUCT_DESC: Irrigation pipe of unknown size and material through the levee of an unknown depth below the crown. Pipe capped with valve inside of 6-inch steel standpipe located on the landside (LS) shoulder. No permit has been identified since crossing was field discovered in 2012. FS Date: 5/16/2016 10:31:49 AM

Overview looking D/S

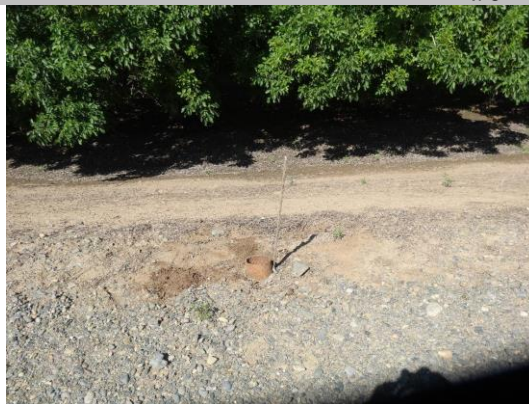
Photo 2 of 3 : UCIP_SP_2017_47873_65929.jpg

LS slope with steel standpipe

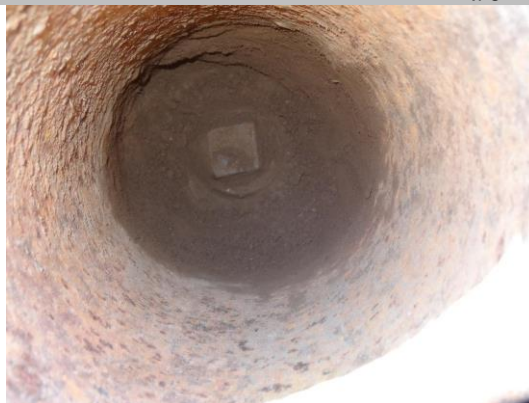
Photo 3 of 3 : UCIP_SP_2017_47873_65932.jpg

Inside of steel standpipe with cap

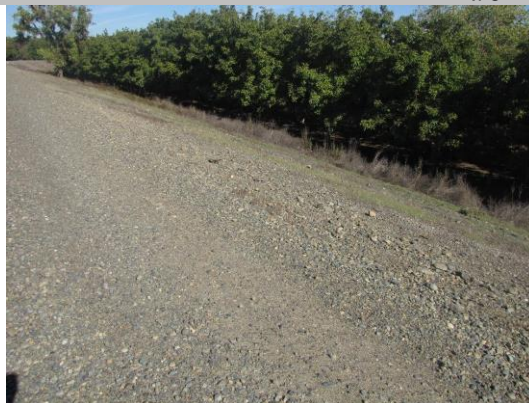
Photo 1 of 3 : UCIP_SP_2017_47874_65936.jpg

FS_ID:47874
DS_ID:16949
EP_NO: 14200
Repair Type: Non-Urgent
Crossing Status: Indicator Found
UCIP Comments: 5/16/2016 Feather River West Levee Improvement Project--Levee currently under construction.6/10/2015 Same as last inspection.12/30/2014 Same as last inspection.5/19/2014 Same as last inspection.11/7/2013 Same as last inspection.5/13/2013 SBFCA project recommends relacing in accordance with title 23.5/10/2013 Appears to just be surface erosion and not a crossing. Will keep monitoring until sure.11/5/2012 LS shoulder, small hole with too much moisture; rocks look wet last rain event occurred 4 days ago.
FIELD_STRUCT_DESC: 2-inch galvanized water pipe through the levee, 2 feet below the crown. (Permit No. 14200, 1985 - Clinton W. Moffitt) [Additional Reference(s): DWR Levee Log, 2005]
FS Date: 5/16/2016 10:32:05 AM

View of WS and levee crown looking upstream at crossing alignment.

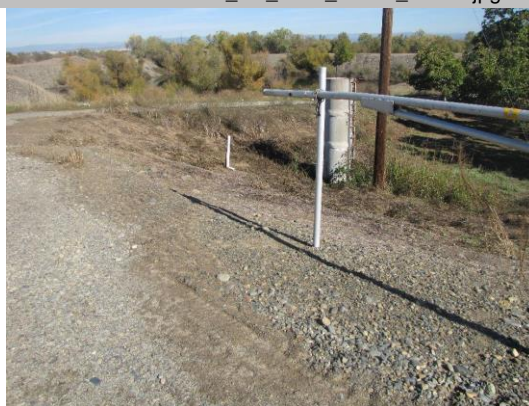
Photo 2 of 3 : UCIP_SP_2017_47989_65940.jpg

Comment Code					
Inspector Comment					
FS_ID:47989 DS_ID:16948 EP_NO: N/A Repair Type: Non-Urgent Crossing Status: Found UCIP Comments: 5/16/2016 Feather River West Levee Improvement Project--Levee currently under construction.6/11/2015 WS standpipe was overgrown with blackberries and unable to be inspected.12/30/2014 Same as last inspection.5/20/2014 Same as last inspection.11/7/2013 Same as last inspection.5/13/2013 SBFCA project recommends relacing in accordance with title 23.5/10/2013 Same as last inspection. Cleared back some of the black berries but live birds nest on ladder prevented me from inspecting inside of standpipe. Recommend spraying the black berries to clear path to ladder.11/5/2012 unable to determine the condition of the slide gate inside WS concrete standpipe blackberry shrubs overgrown against access latter. FIELD_STRUCT_DESC: 12-inch steel irrigation pipe through the levee, 14 feet below the crown. Slide gate in 36-inch concrete standpipe at the waterside (WS) toe. Concrete distribution box at the landside (LS) toe. [Additional Reference(s): DWR Levee Log, 2005] FS Date: 5/16/2016 10:32:00 AM

View of WS and levee shoulder looking upstream at crossing. Crossing appurtances include concrete riser and power pole.

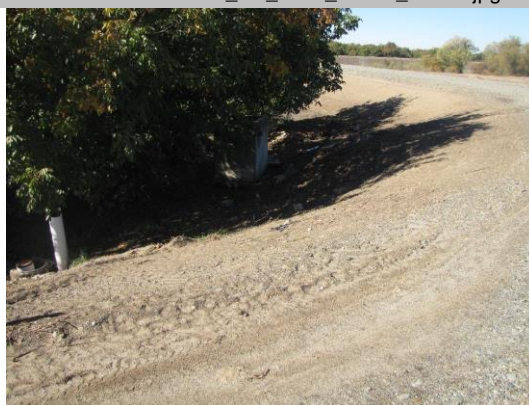
Photo 3 of 3 : UCIP_SP_2017_47989_65942.jpg

View of LS looking upstream at crossing. Concrete distribution box located on LS toe.

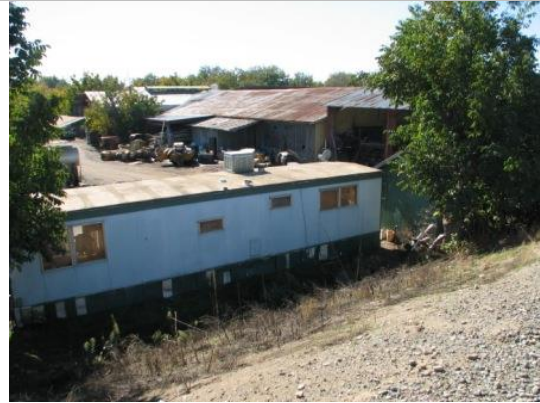
Photo 1 of 1 : SP_2017_MA0007_200_45_20170316_00006.jpg

LM Start	9.65	Rating **	U	Issue No.	45
LM End	9.65	Issue Type +	En	Location *	LS
Category	Earthen Levee			GPS Latitude/Longitude	
				Start	End
Item	Encroachments			39.416384 °	39.416384 °
				-121.634503 °	-121.634503 °
DWR ID	DWR_MA0007_01_s_2012_45				
Comment Code					
BU : Building					
Inspector Comment

This photo shows a building at the landside toe.

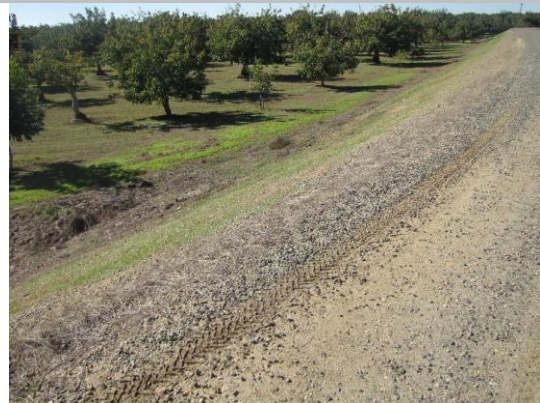
Photo 1 of 3 : UCIP_SP_2017_47990_65946.jpg

Comment Code					
Inspector Comment					
FS_ID:47990 DS_ID:16947 EP_NO: N/A Repair Type: Non-Urgent Crossing Status: Indicator Found UCIP Comments: 5/16/2016 Feather River West Levee Improvement Project--Levee currently under construction. Crossing, referenced as STA 2201+87, will be removed and replaced as indicated in the project Plans for Construction of Feather River West Levee Project, Project Area A, Feather River West Levee Improvement Plans, Sta 1765+00 to 2368+26, Volume 3 of 5.6/11/2015 Abandoned crossing. SBFCA project recommends removal.12/30/2014 Same as last inspection.5/20/2014 Same as last inspection.11/7/2013 Same as last inspection.5/13/2013 SBFCA project recommends removal.5/10/2013 Same as last inspection.11/5/2012 Crossing appears to be abandoned; slide gate located inside concrete standpipe is buried with trash; no other features were visible during inspection. This crossing needs to be properly abandoned. FIELD_STRUCT_DESC: *ABANDONED* 10-inch reinforced concrete encased steel irrigation pipe through the levee, 14.5 feet below the crown. Slide gate in 24-inch concrete standpipe at the waterside (WS) toe. [Additional Reference(s): DWR Levee Log, 2005. USACE Sacramento O&M Manual 152, March 1957 (Station 437+30)] FS Date: 5/16/2016 10:32:00 AM

View of LS and levee crown looking upstream at crossing.

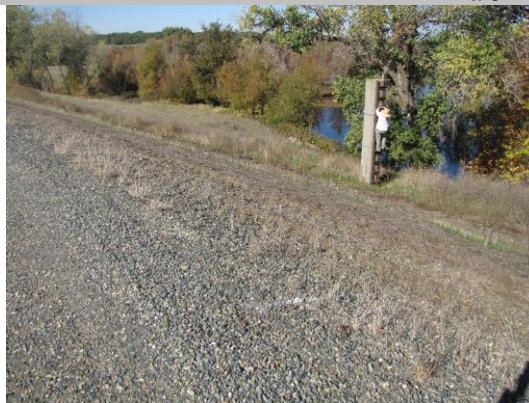
Photo 2 of 3 : UCIP_SP_2017_47990_65945.jpg

View of WS shoulder and slope looking upstream at crossing.

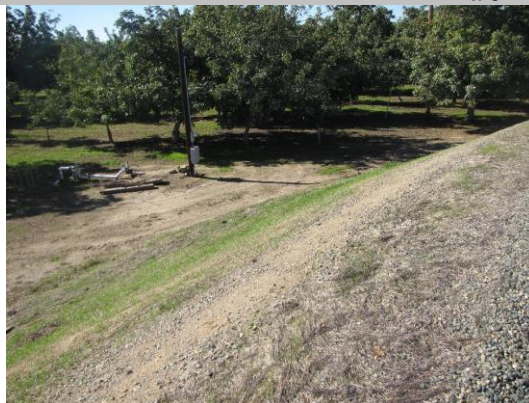
Photo 1 of 3 : UCIP_SP_2017_47878_65947.jpg

FS_ID:47878
DS_ID:16946
EP_NO: N/A
Repair Type: Non-Urgent
Crossing Status: Indicator Found
UCIP Comments: 5/16/2016 Feather River West Levee Improvement Project--Levee currently under construction.6/11/2015 Same as last inspection.12/30/2014 Same as last inspection.5/20/2014 Same as last inspection.11/7/2013 Same as last inspection.5/13/2013 SBFCA project recommends removal.5/10/2013 Same as last inspection.11/5/2012 unable to determine if this crossing still is in use, signs of depression on waterward shoulder, pump located on LS (GW?) valve on waterward toe. No slide gate or concrete standpipe present; structure appears to have been modified--need permit issued for modifications.
FIELD_STRUCT_DESC: 10-inch steel irrigation pipe through the levee, 14.5 feet below the crown. Slide gate in concrete standpipe and pump on the landside (LS). [Additional Reference(s): DWR Levee Log, 2005]
FS Date: 5/16/2016 10:32:59 AM

View of LS and levee slope. Pump located on LS toe--GW pump or part of structure.

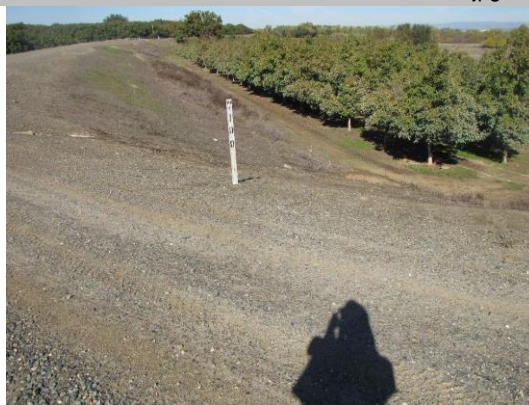
Photo 2 of 3 : UCIP_SP_2017_47878_65952.jpg

View of WS and levee crown looking upstream at crossing.

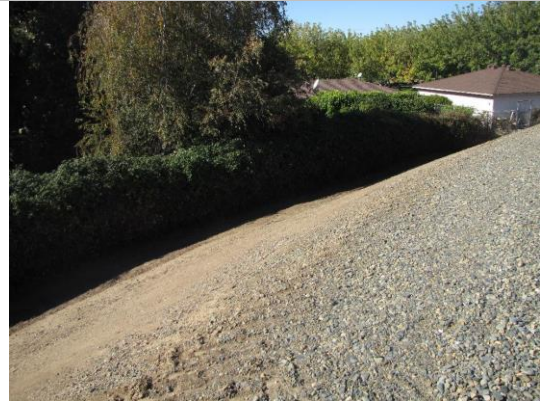
Photo 1 of 3 : UCIP_SP_2017_47991_65953.jpg

View of LS--no signs of crossing or appurtances are present.

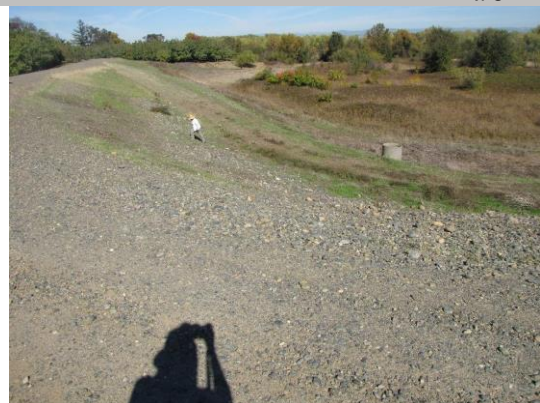
Photo 2 of 3 : UCIP_SP_2017_47991_65956.jpg

View of WS looking upstream at slope and concrete standpipe.

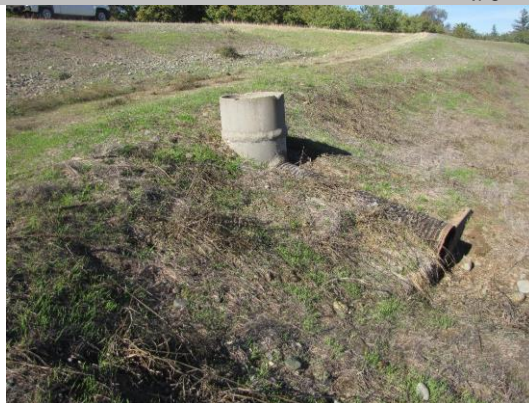
Photo 3 of 3 : UCIP_SP_2017_47991_65955.jpg

FIELD_STRUCT_DESC: 24-inch corrugated metal drainage pipe through the levee, 14.5 feet below the crown. Concrete headwall at both waterside (WS) and landside (LS) toes. Flap gate in 36-inch concrete standpipe on the berm. [Additional Reference(s): DWR Levee Log, 2005. USACE Sacramento O&M Manual 152, March 1957 (Station 471+26)]
FS Date: 5/16/2016 10:33:00 AM

View of concrete standpipe located on WS.

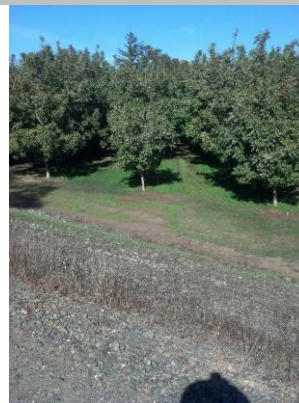
Photo 3 of 3 : UCIP_SP_2017_47992_65957.jpg

Item	DWR UCIP Field Study			39.428380 °		39.428380 °
				-121.642228 °		-121.642228 °
DWR ID						
Comment Code						
Inspector Comment						
FS_ID:47992 DS_ID:16944 EP_NO: N/A Repair Type: Non-Urgent Crossing Status: Indicator Found UCIP Comments: 5/16/2016 Feather River West Levee Improvement Project--Levee currently under construction. Crossing, referenced as STA 2245+52, will be removed per the project Plans for Construction of Feather River West Levee Project, Project Area A, Feather River West Levee Improvement Plans, Sta 1765+00 to 2368+26, Volume 3 of 5.6/11/2015 Headwall still buried. SBFCA project recommends removal.12/30/2014 Same as last inspection.5/20/2014 Same as last inspection.11/7/2013 Same as last inspection.5/13/2013 SBFCA project recommends removal.5/10/2013 Same as last inspection.11/5/2012 crossing appears to be abandoned--unknown method of abandonment; headwall buried with a small section of headwall exposed. FIELD_STRUCT_DESC: *ABANDONED* 24-inch corrugated metal drainage pipe through the levee, 17.5 feet below the crown. Concrete headwall at landside (LS) toe. Flap gate located on the waterside (WS) end covered with dirt. [Additional Reference(s): DWR Levee Log, 2005. USACE Sacramento O&M Manual 152, March 1957 (Station 476+60)] FS Date: 5/16/2016 10:33:00 AM

View of WS.

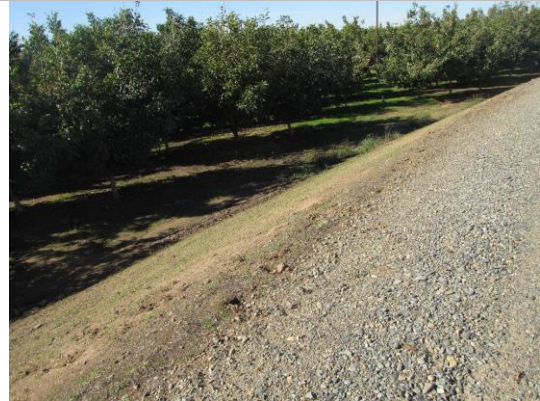
Photo 1 of 3 : UCIP_SP_2017_47993_65970.jpg

View of LS looking upstream at crossing.

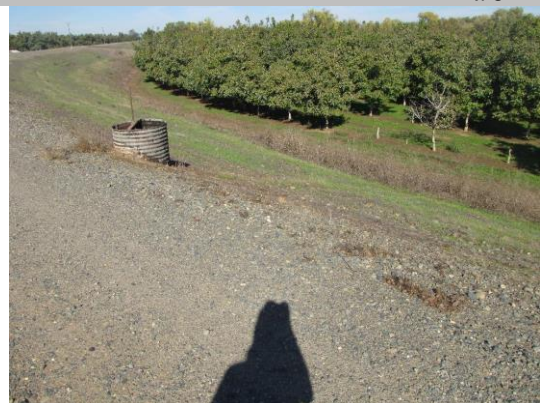
Photo 2 of 3 : UCIP_SP_2017_47993_65969.jpg

View of WS looking upstream at crossing. CMP riser located on WS shoulder.

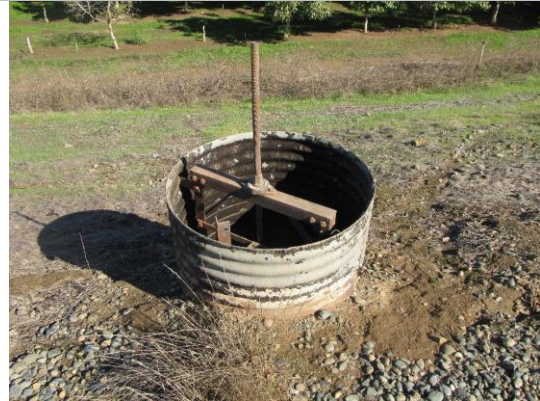
Photo 3 of 3 : UCIP_SP_2017_47993_65968.jpg

FS_ID:47993
DS_ID:16941
EP_NO: N/A
Repair Type: Non-Urgent
Crossing Status: Found
UCIP Comments: 5/16/2016 Feather River West Levee Improvement Project--Levee currently under construction. Crossing, referenced as STA 2256+71, will be removed as indicated in the project Plans for Construction of Feather River West Levee Project, Project Area A, Feather River West Levee Improvement Plans, Sta 1765+00 to 2368+26, Volume 3 of 5.6/11/2015 Same as last inspection.12/30/2014 Same as last inspection.5/20/2014 Same as last inspection.11/7/2013 Same as last inspection.5/13/2013 SBFCA project recommends removal.5/10/2013 Top cover has fallen down inside standpipe and may prevent gate from fully closing. Wheel to operate gate still missing.11/5/2012 WS-missing top cover of the CMP riser; debris inside CMP riser; wheel handle missing from slide gate. Unable to determine condition of slide gate face. LS-crossing not visible. This crossing was listed in the USACE Periodic Inspection as ID# USACE_CESPK_MA07_2010_a_0330 no issues reported. FIELD_STRUCT_DESC: 24-inch reinforced concrete encased corrugated metal irrigation pipe through the levee, 21 feet below the crown. Slide gate in 36-inch corrugated metal pipe (CMP) riser on the waterside (WS) slope. [Additional Reference(s): DWR Levee Log, 2005. USACE Sacramento O&M Manual 152, March 1957 (Station 490+50)] FS Date: 5/16/2016 10:34:00 AM

WS view of CMP with slide gate inside.

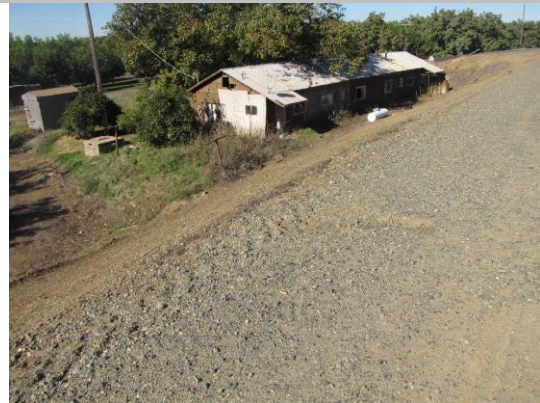
Photo 1 of 3 : UCIP_SP_2017_47958_65974.jpg

LM Start	11.08	Rating **	M	Issue No.	100 (cont)
LM End	11.08	Issue Type +	Ma	Location *	LS

View of LS looking upstream at crossing.

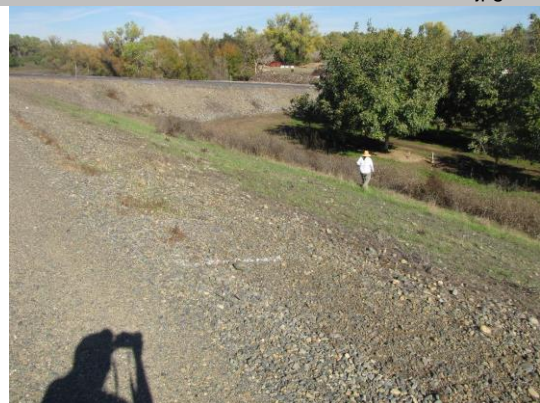
Photo 2 of 3 : UCIP_SP_2017_47958_65973.jpg

View of WS looking upstream at crossing.

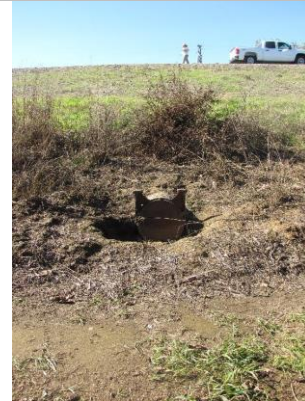
Photo 3 of 3 : UCIP_SP_2017_47958_65977.jpg

Item	DWR UCIP LMA Responsibility			39.431546 °	39.431546 °	
				-121.645474 °	-121.645474 °	
DWR ID						
Comment Code						
Inspector Comment						
FS_ID:47958 DS_ID:16939 EP_NO: N/A Repair Type: Non-Urgent Crossing Status: Found UCIP Comments: 5/16/2016 Feather River West Levee Improvement Project--Levee currently under construction. Crossing, referenced as STA 2260+55, will be removed as indicated in the project Plans for Construction of Feather River West Levee Project, Project Area A, Feather River West Levee Improvement Plans, Sta 1765+00 to 2368+26, Volume 3 of 5.6/11/2015 Both pipe ends are beeing overgrown by vegetation and are getting hard to inspect. Vegetation needs to be cleared away.12/30/2014 Same as last inspection.5/20/2014 Same as last inspection.11/7/2013 Same as last inspection.5/13/2013 SBFCFA project recommends relacing in accordance with title 23.5/10/2013 Same as last inspection. Talking with farmer he said the pipe may be getting removed.11/5/2012 flash boards missing on LS. This crossing was listed in the USACE Periodic Inspection as ID# USACE_CESPK_MA07_2010_a_0332 no issues reported. FIELD_STRUCT_DESC: 24-inch corrugated metal drainage pipe through the levee. 18.9 feet below the crown. Flap gate on the waterside (WS) end. [Additional Reference(s): DWR Levee Log, 2005. USACE Sacramento O&M Manual 152, March 1957 (Station 494+50)] FS Date: 5/16/2016 10:34:00 AM

View of WS slope and outlet.

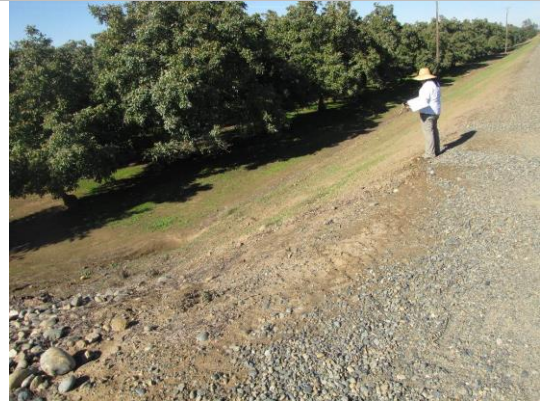
Photo 1 of 3 : UCIP_SP_2017_47994_65979.jpg

LM Start	11.12	Rating **	M	Issue No.	101 (cont)
LM End	11.12	Issue Type +	Ma	Location *	LS

View of LS looking upstream at crossing.

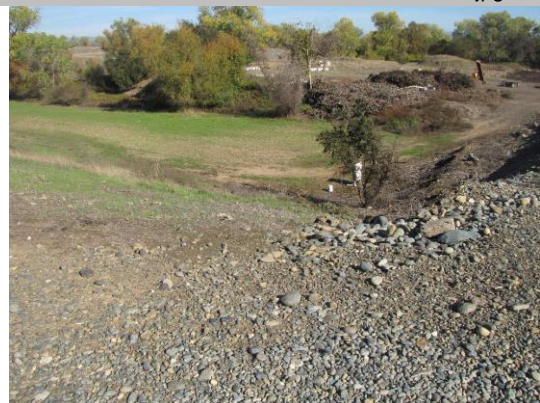
Photo 2 of 3 : UCIP_SP_2017_47994_65978.jpg

View of WS looking upstream at crossing.

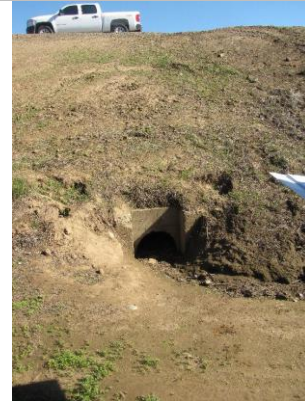
Photo 3 of 3 : UCIP_SP_2017_47994_65982.jpg

Item	DWR UCIP LMA Responsibility			39.432143 °	39.432143 °	
				-121.645516 °	-121.645516 °	
DWR ID						
Comment Code						
Inspector Comment						
FS_ID:47994 DS_ID:16938 EP_NO: N/A Repair Type: Non-Urgent Crossing Status: Found UCIP Comments: 5/16/2016 Feather River West Levee Improvement Project--Levee currently under construction. Crossing, referenced as STA 2262+69, will be removed and replaced with a new 36-inch pipe as indicated in the project Plans for Construction of Feather River West Levee Project, Project Area A, Feather River West Levee Improvement Plans, Sta 1765+00 to 2368+26, Volume 3 of 5.6/11/2015 Scour still present near the WS apron. 12/30/2014 Same as last inspection.5/20/2014 Same as last inspection.11/7/2013 Same as last inspection.5/10/2013 Same as last inspection.5/13/2013 SBFCA project recommends relacing in accordance with title 23.11/5/2012 burrow activity near headwall on LS; scour near concrete apron and below apron; This crossing was listed in the USACE Periodic Inspection as ID# USACE_CESPK_MA07_2010_a_0336 no issues reported. FIELD_STRUCT_DESC: 24-inch corrugated metal drainage pipe through the levee, 15.8 feet below the crown. Concrete headwall at both waterside (WS) and landside (LS) toes. Flap gate on the WS end. [Additional Reference(s): DWR Levee Log, 2005. USACE Sacramento O&M Manual 152, March 1957 (Station 496+20)] FS Date: 5/16/2016 10:35:00 AM

View of inlet located on LS.

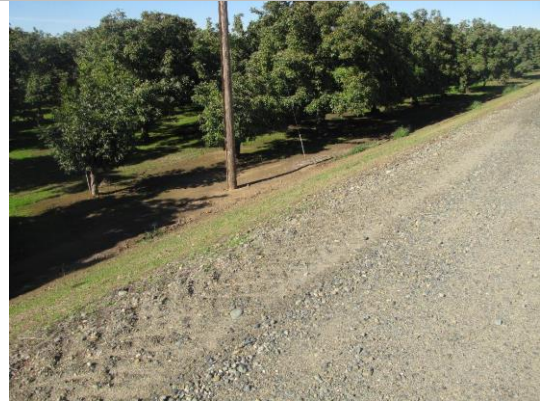
Photo 1 of 3 : UCIP_SP_2017_47960_65987.jpg

LM Start	11.23	Rating **	M	Issue No.	102 (cont)
LM End	11.23	Issue Type +	En	Location *	LS

View of LS looking upstream at crossing.

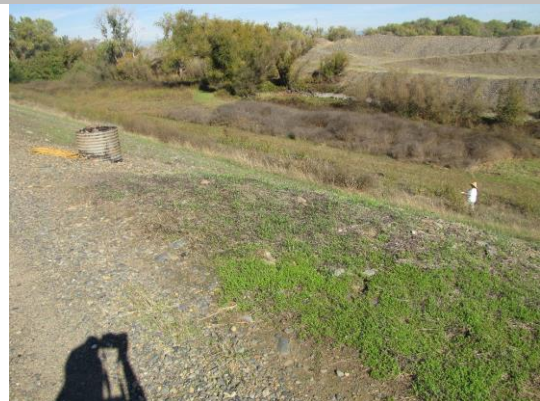
Photo 2 of 3 : UCIP_SP_2017_47960_65985.jpg

View of WS looking upstream at crossing.

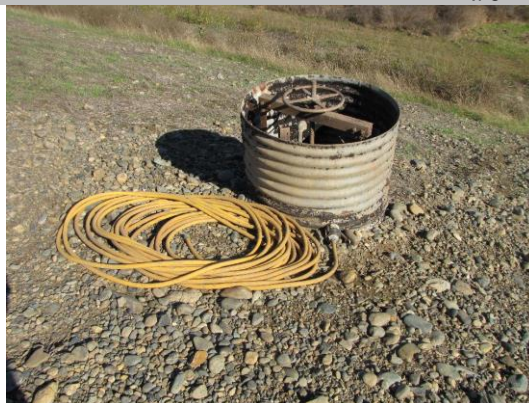
Photo 3 of 3 : UCIP_SP_2017_47960_65986.jpg

CMP riser located on WS shoulder.

Comment Code					
Inspector Comment					
FS_ID:47960 DS_ID:16937 EP_NO: N/A Repair Type: Non-Urgent Crossing Status: Found UCIP Comments: 5/16/2016 Feather River West Levee Improvement Project--Levee currently under construction. Crossing, referenced as STA 2268+27, will be removed as indicated in the project Plans for Construction of Feather River West Levee Project, Project Area A, Feather River West Levee Improvement Plans, Sta 1765+00 to 2368+26, Volume 3 of 5.6/11/2015 Abandoned crossing. SBFCA project recommends removal.12/30/2014 Same as last inspection.5/20/2014 Same as last inspection.11/7/2013 Same as last inspection.5/13/2013 SBFCA project recommends removal.5/10/2013 Same as last inspection.11/5/2012 Abandoned pipe-need to properly abandon structure; CMP riser cover missing on WS; WS pipe filled with concrete; LS crossing not visible. FIELD_STRUCT_DESC: *ABANDONED* 24-inch reinforced concrete encased corrugated metal irrigation pipe through the levee, 19.5 feet below the crown. Concrete headwall at the landside (LS) toe. Slide gate in 36-inch corrugated metal pipe (CMP) riser on the waterside (WS) slope. [Additional Reference(s): DWR Levee Log, 2005. USACE Sacramento O&M Manual 152, March 1957 (Station 502+20)] FS Date: 5/16/2016 10:56:00 AM

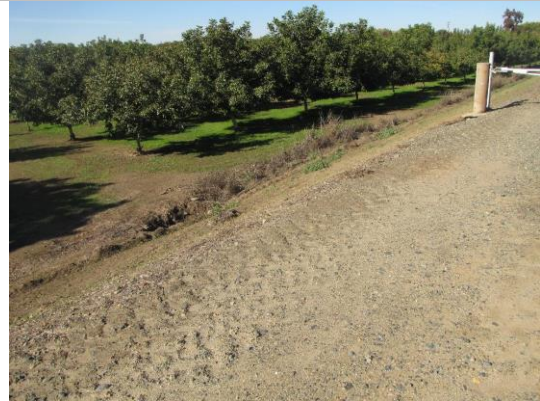
Photo 1 of 3 : UCIP_SP_2017_48009_65990.jpg

LM Start	11.35	Rating **	M	Issue No.	103 (cont)
LM End	11.35	Issue Type +	Ma	Location *	LS

View of LS looking upstream at crossing.

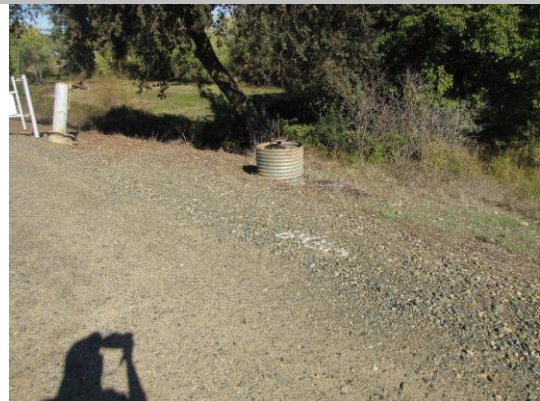
Photo 2 of 3 : UCIP_SP_2017_48009_65994.jpg

View of WS looking upstream at crossing.

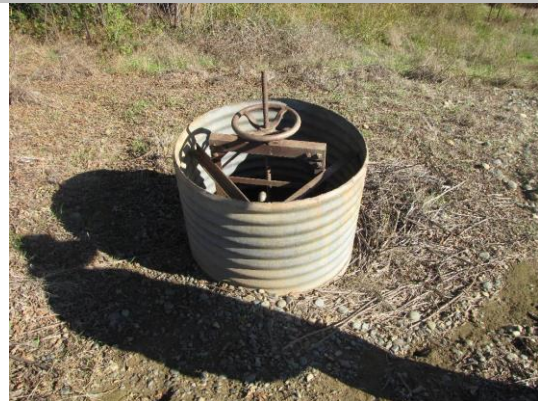
Photo 3 of 3 : UCIP_SP_2017_48009_65992.jpg

FS_ID:48009
DS_ID:16936
EP_NO: N/A
Repair Type: Non-Urgent
Crossing Status: Found
UCIP Comments: 5/16/2016 Feather River West Levee Improvement Project--Levee currently under construction. Crossing, referenced as STA 2274+86, will be removed as indicated in the project Plans for Construction of Feather River West Levee Project, Project Area A, Feather River West Levee Improvement Plans, Sta 1765+00 to 2368+26, Volume 3 of 5.6/11/2015 LS inlet is still mostly buried with soil. SBFCA project recommends removal.12/30/2014 Same as last inspection.5/20/2014 Same as last inspection.5/13/2013 SBFCA project recommends removal.5/10/2013 Same as last inspection. LS inlet excavated but more than 50% still covered by soil.11/7/2013 Same as last inspection.11/5/2012 Non-functional crossing LS inlet buried; WS-debris in CMP riser, riser missing lid; This crossing was listed in the USACE Periodic Inspection as ID# USACE_CESPK_MA07_2010_a_0344 for pipes filled > 50 % with soil. FIELD_STRUCT_DESC: 24-inch corrugated metal drainage pipe through the levee, 16.2 feet below the crown. Concrete headwall at both waterside (WS) and landside (LS) toes. Flap gate on the WS end. [Additional Reference(s): DWR Levee Log, 2005. USACE Sacramento O&M Manual 152, March 1957 (Station 508+40)]

CMP riser located on WS slope.

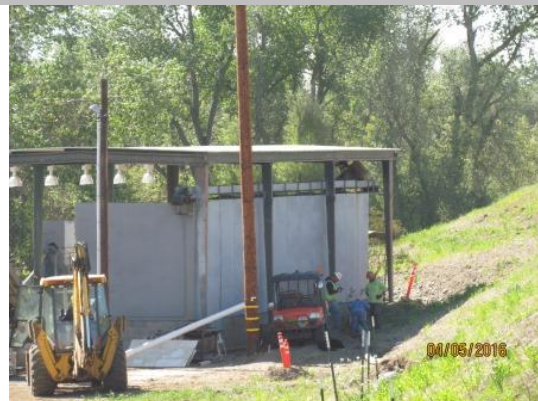
Photo 1 of 1 : SP_2017_MA0007_200_40_20170316_00003.jpg

LM Start	11.49	Rating **	M	Issue No.	40
LM End	11.49	Issue Type +	En	Location *	WS
Category	Earthen Levee			GPS Latitude/Longitude	
				Start	End
Item	Encroachments			39.437454 °	39.437454 °
				-121.646024 °	-121.646024 °
DWR ID	DWR MA0007 01 s 2016 40

View showing structure, waterside, looking downstream.

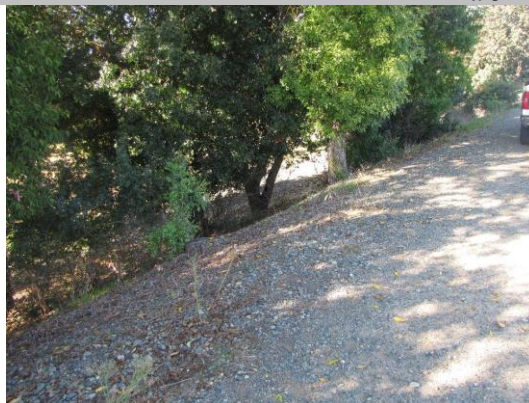
Photo 1 of 3 : UCIP_SP_2017_47997_65996.jpg

LM Start	11.51	Rating **	M	Issue No.	104 (cont)
LM End	11.51	Issue Type +	En	Location *	WS

View of LS looking upstream at crossing.

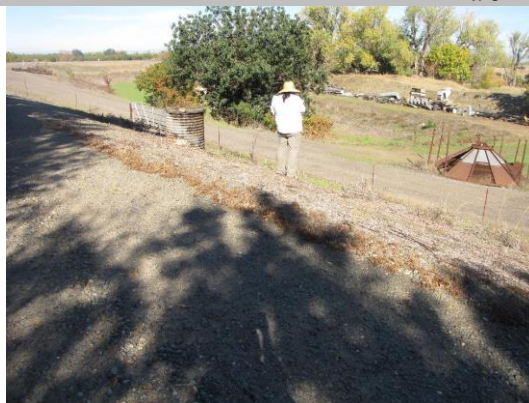
Photo 2 of 3 : UCIP_SP_2017_47997_65995.jpg

View of WS looking upstream at crossing.
